For
MESH DYNAMICS
SYSTEM INTEGRATORS
RADIO CARD DIAGNOSTICS

RADIO CARD REPLACEMENT

WEATHER BOOT INSTALL

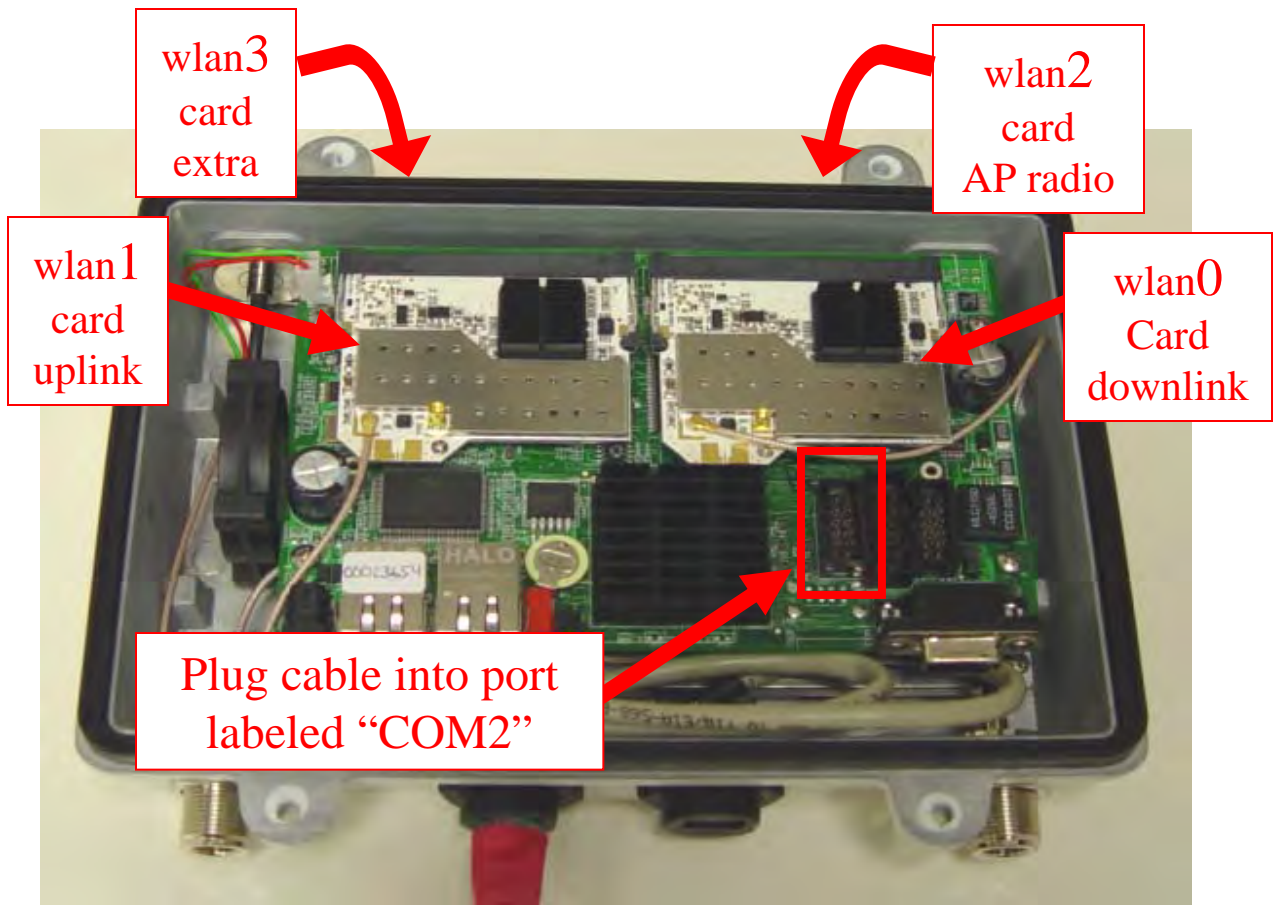
For this particular node, the downlink radio card (indicated as “wlan0”) was intentionally replaced with a damaged card.

It can be seen on the last page of this boot-up process that the node is seeing wlan0 as an “**unknown interface: No such device**” (this is marked by the red square). This message will be displayed whenever a particular card is damaged or dislodged.

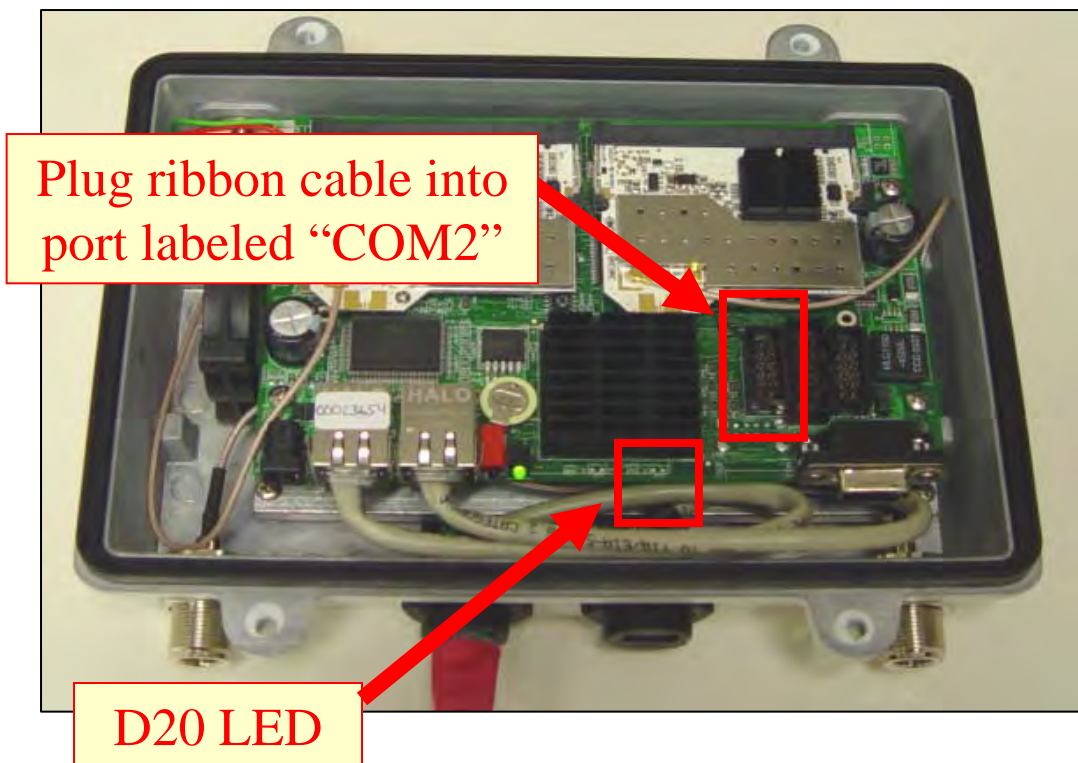
Plug serial ribbon cable into COM2 port.

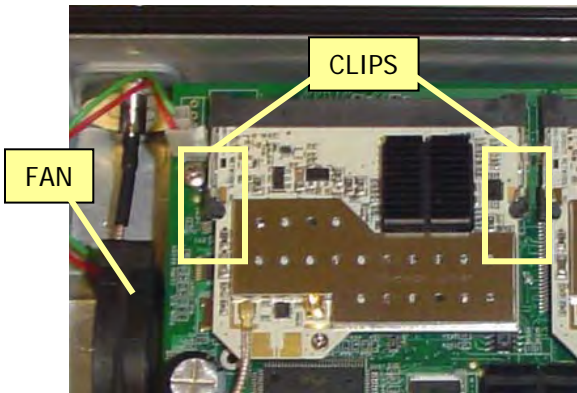
Fig.1

Step 1) Once the lid is removed, disconnect the uplink and downlink radio cards from their slots. To disconnect the cards, remove the clips (Fig.1) from the edge of the cards using thumbnails. Pulling the clips away from the card (Fig.2).

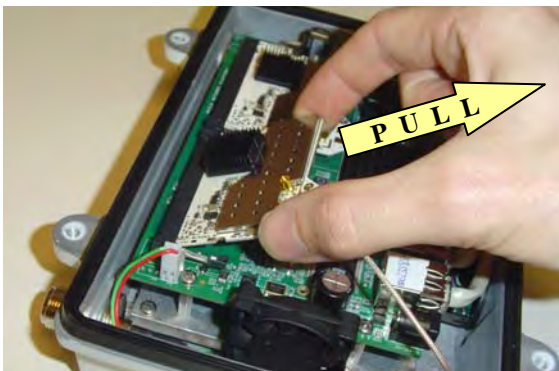
Fig.3

After the radio card is free from the clips, it must be pulled from the slot at an angle as seen below (Fig.3). After each radio card is removed from the slot, be sure the pigtail remains connected and set the cards next to the node (Fig.4). Avoid putting strain on the pigtail where it connects to the radio card.

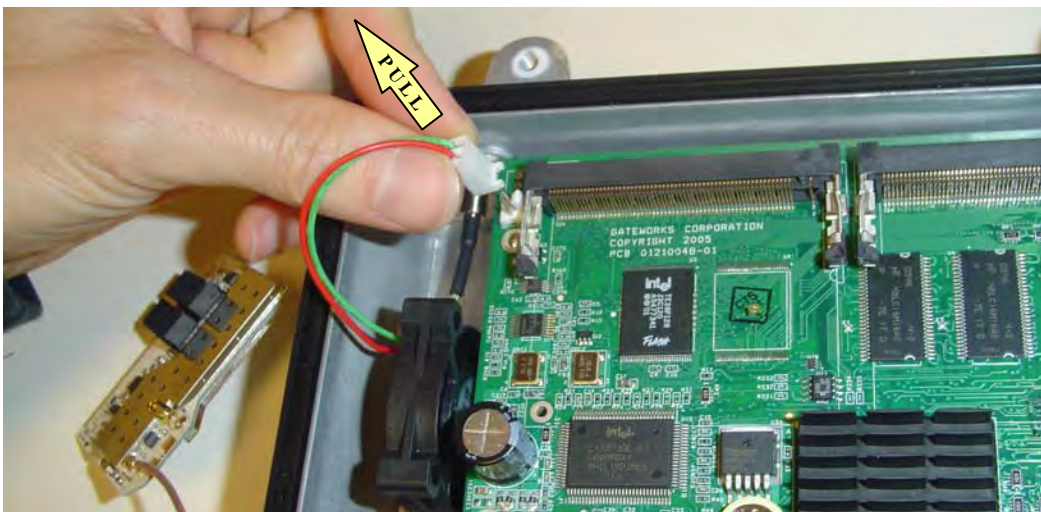
Fig.5

Step 2) Remove the fan connector from the upper-left corner of the motherboard.

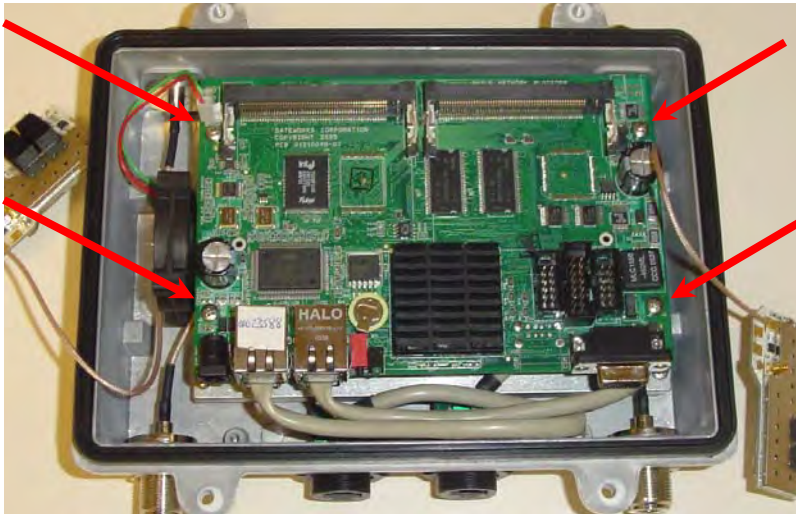
Fig.6

Step 3) Unscrew the motherboard from the node. The motherboard is connected by four screws as seen below (Fig.6).

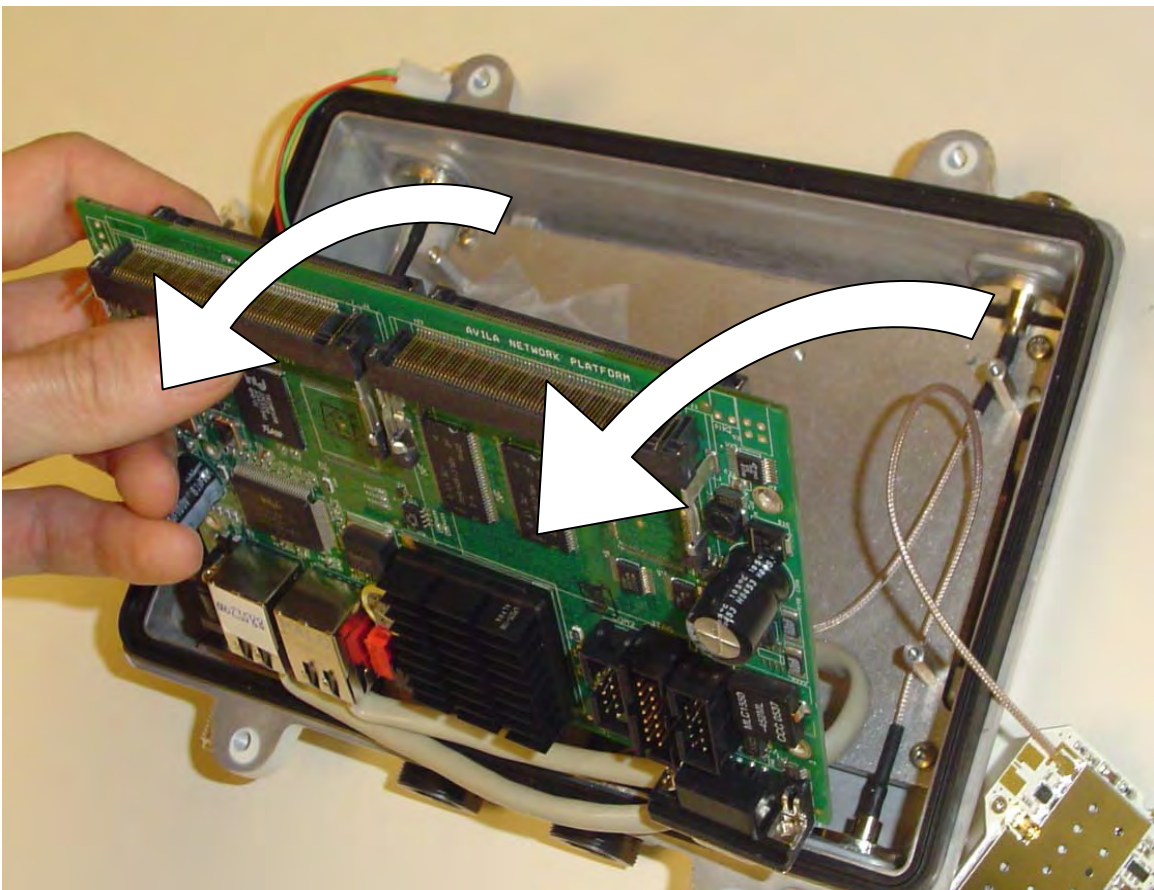
Fig.7

Step 4) Pull the motherboard up leaving the Ethernet cables connected (Fig.7).

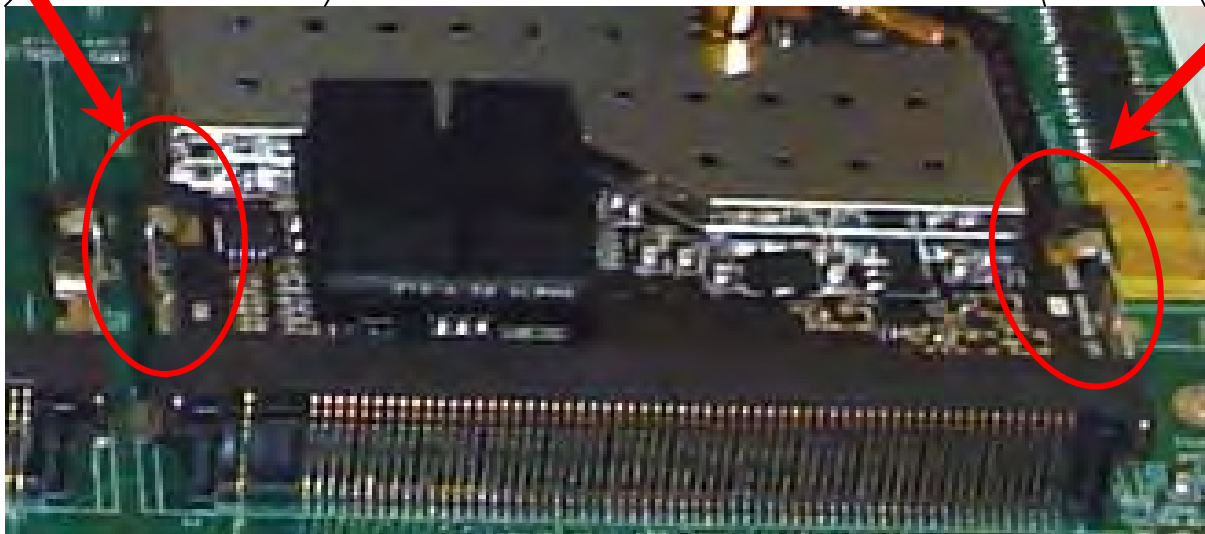
Fig.10

A black radio card will be on the underside of the motherboard. This radio card should be pushed all the way into the slot. If necessary, remove the card all the way from the slot (as done with the top two radio cards), then shove firmly back into the slot. The card will need to be pushed back into the slot at an angle, then pushed towards the motherboard so that the clips will "grab" and hold the card into place. Be sure the clips on the radio card have a secure grip. The clips should be half-way overlapping the gold patches on the radio card as seen in Fig.10.

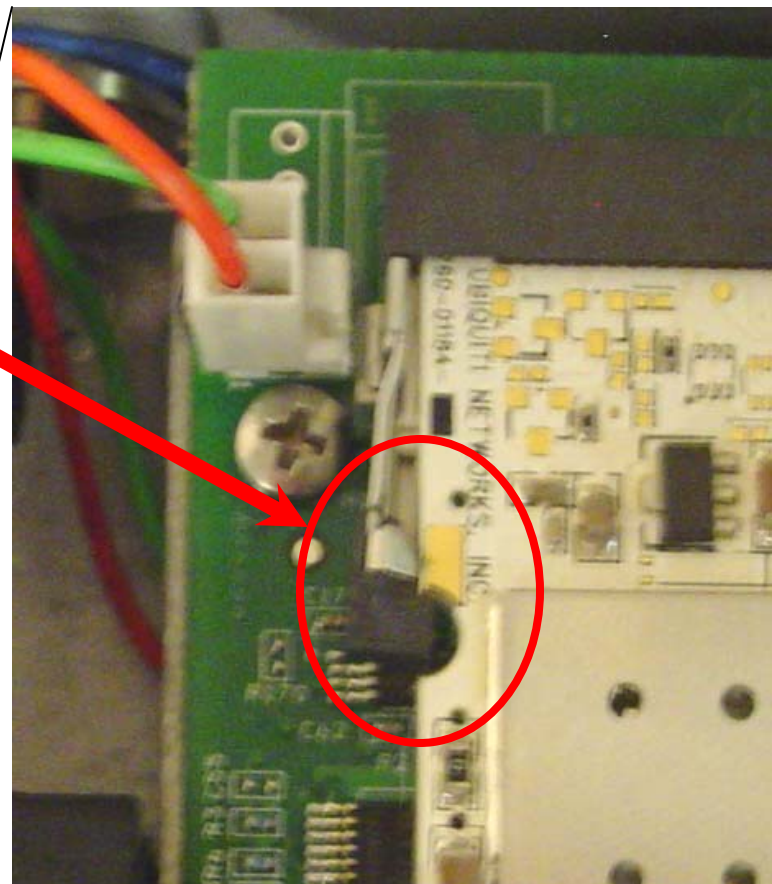
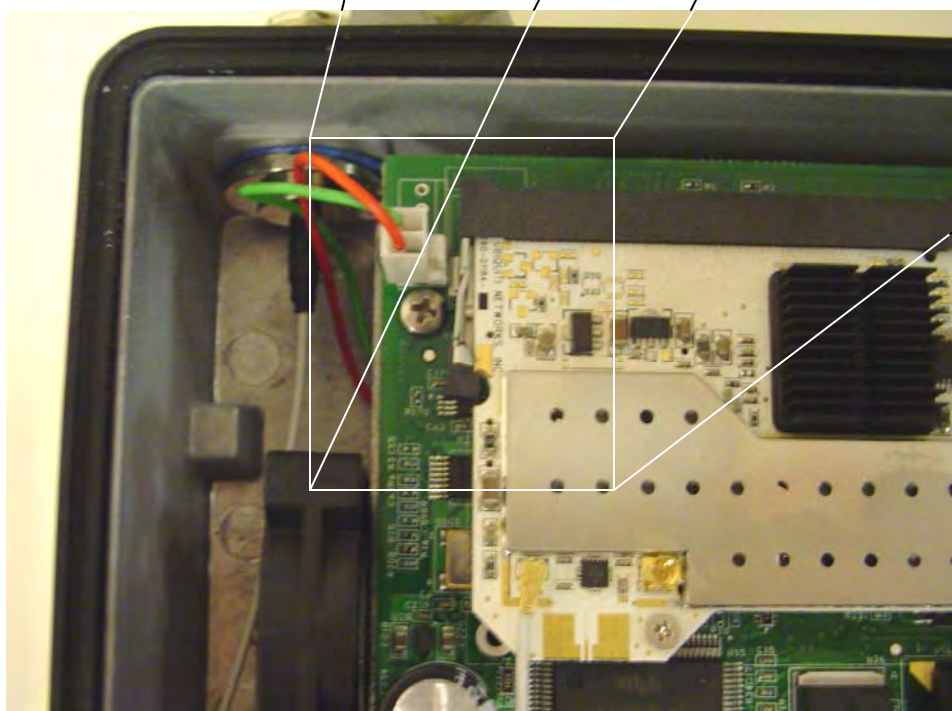
BAD

Clip is off of gold tab on radio card.
This may cause the node not to boot up.

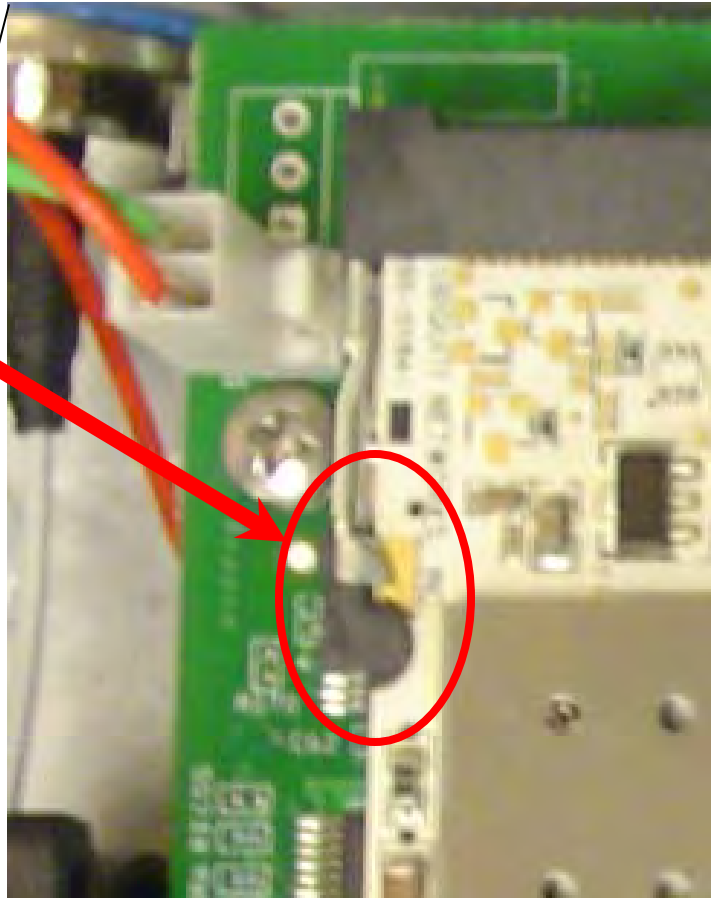
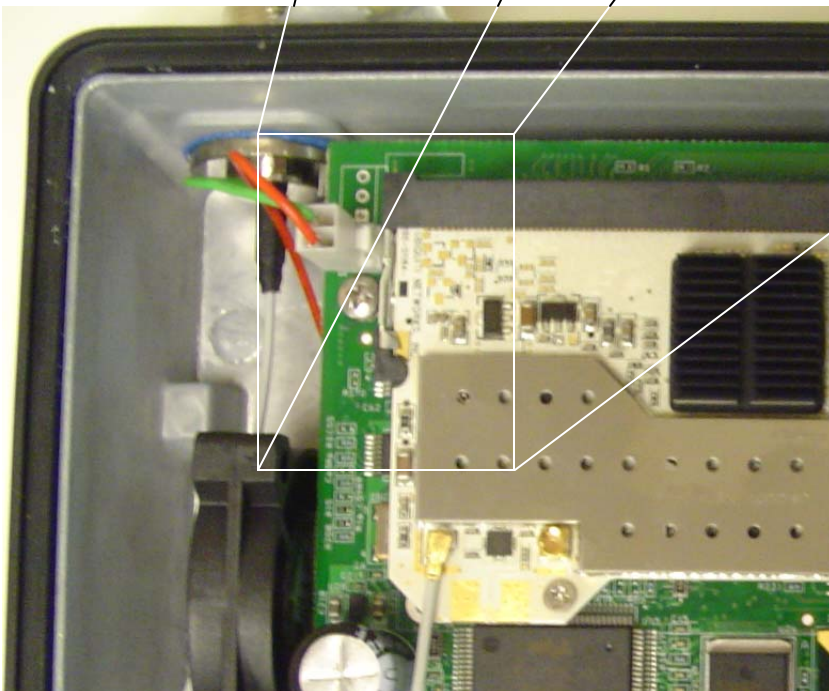
GOOD

Clip *slightly* covers gold tab on radio card. The clips should snap into place if cards are inserted into slot and pushed down towards motherboard properly

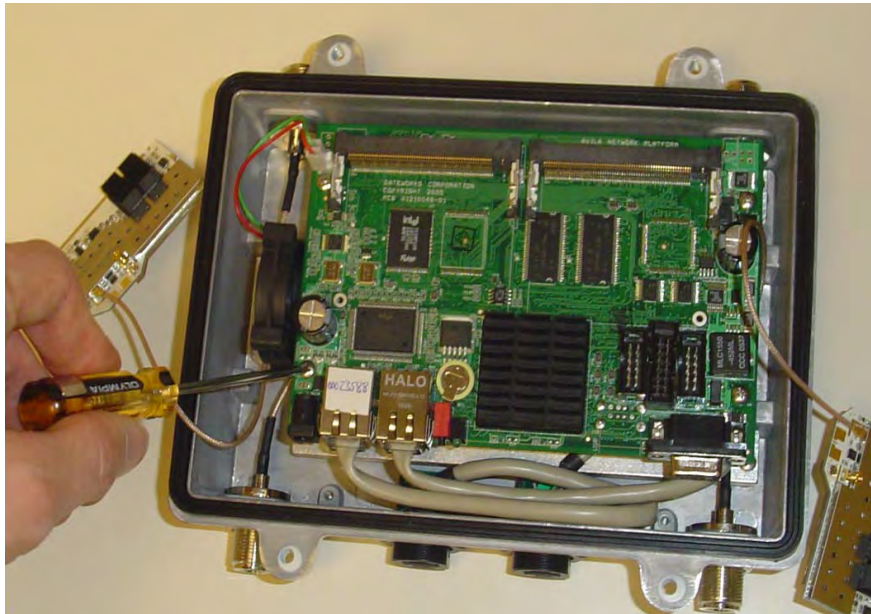
Fig.11

Step 6) Bring the motherboard back to its original position and screw back into place.

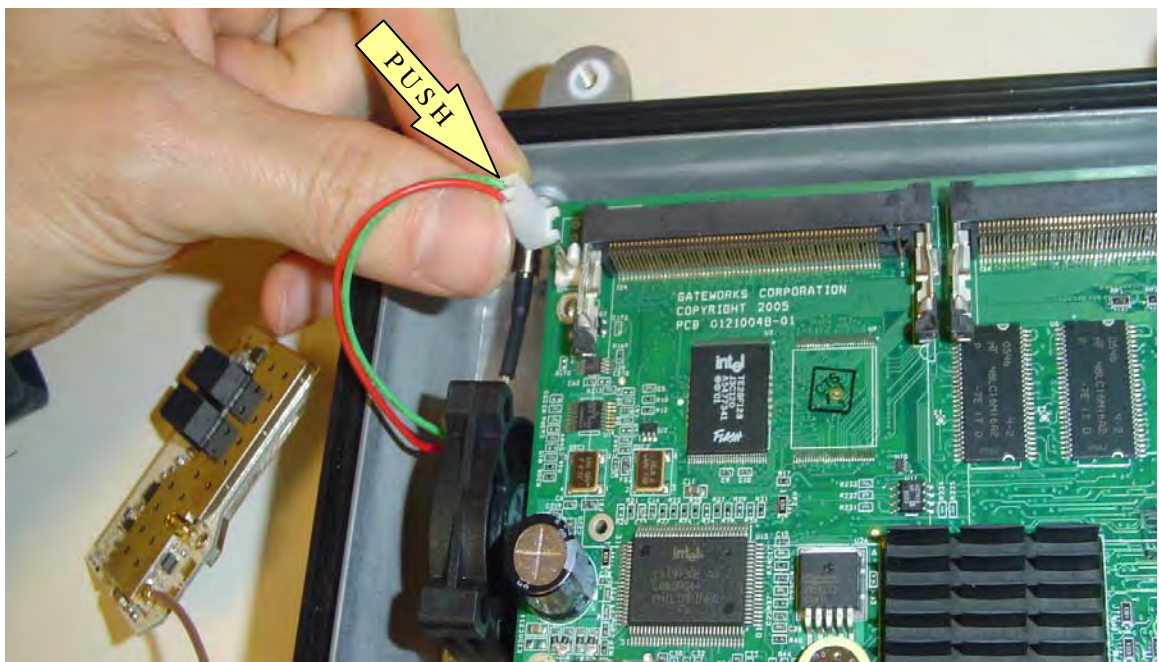
Fig.12

Step 7) Reconnect the fan connector (Fig.12). This should snap into place.

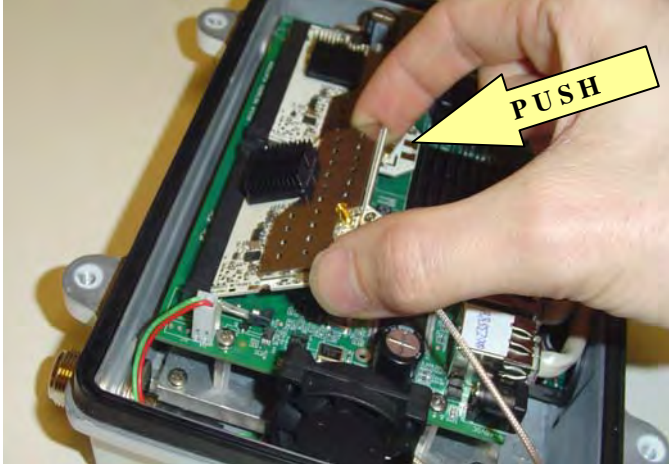
Fig.13

Step 8) Replace the uplink and downlink radio cards. ***This should be done in the same manner the cards are removed from the slots. Insert the card firmly into the slot at an angle to the motherboard (Fig.13), then push the card towards the motherboard allowing the clips to “grab” the card.

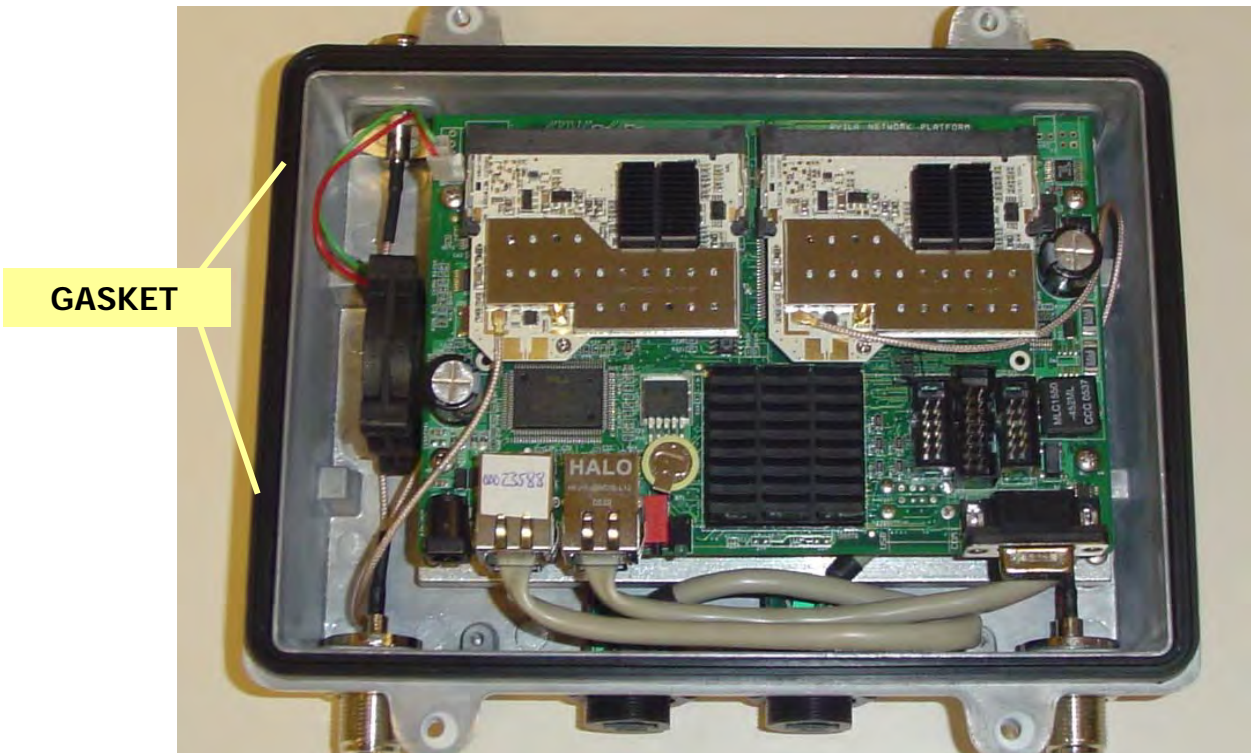
Fig.15

Step 9) Replace the lid of the mesh node. Be sure the grooves of the lid fit appropriately into the “H-shaped” cross-sectioned gasket (Fig...) before tightening the lid bolts

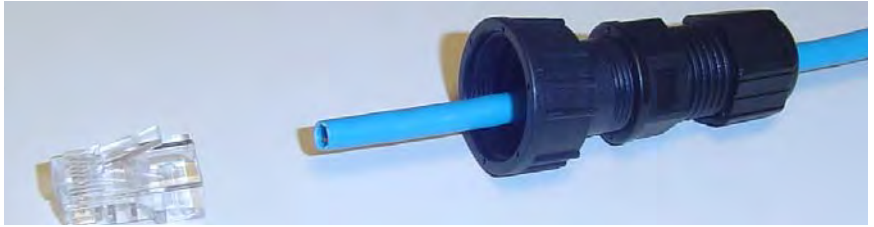
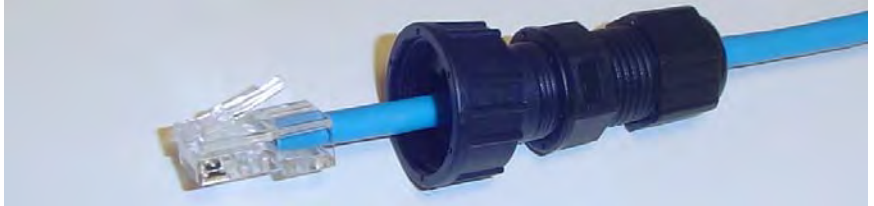
Boot assembly must be slid onto CAT5 cable before RJ45 connector is crimped on.

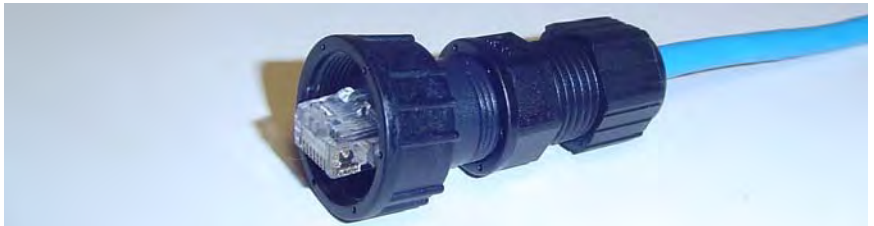
After RJ45 connector is crimped, slide boot assembly over the connector such that the connector clip is tucked *into* boot assembly

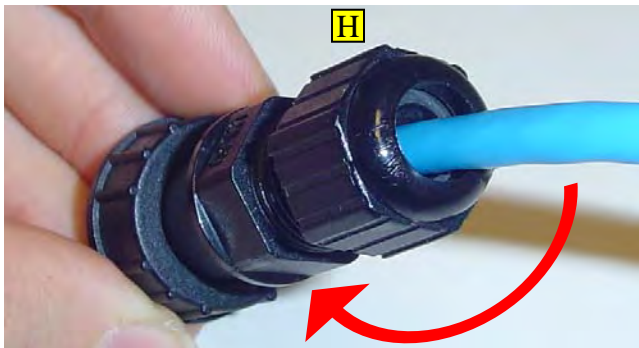
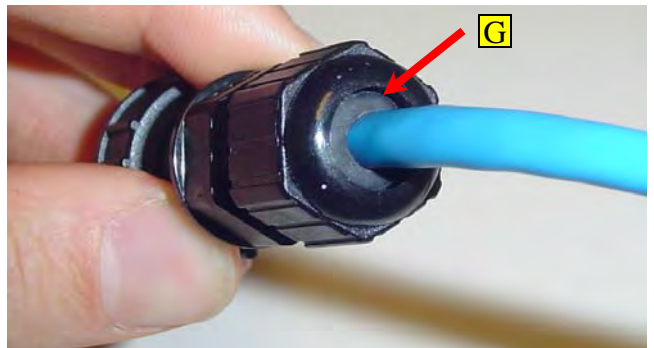
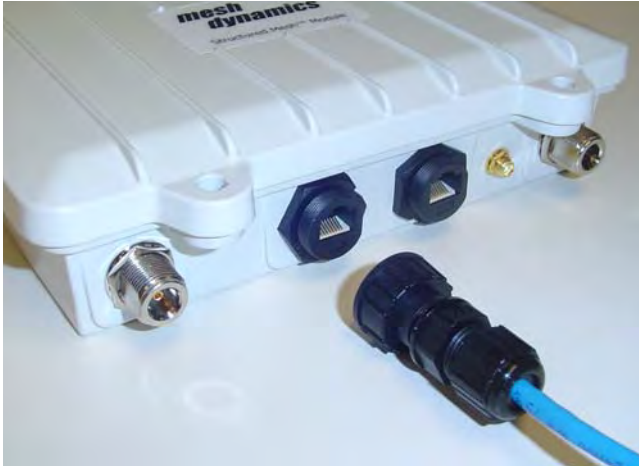
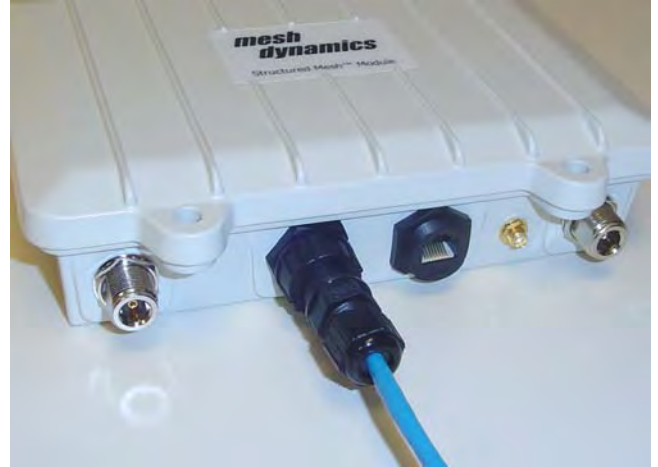
After boot assembly is in place over RJ45 connector, twist part "H" until rubber gasket (part "G") is compressed against CAT5 cable.

The *threads* on the RJ45 port on the mesh node are relatively close together. Make sure the boot assembly is screwed on completely straight with no cross-threading. If connected correctly, there should be **no** gap between the boot and the connector on the mesh node.

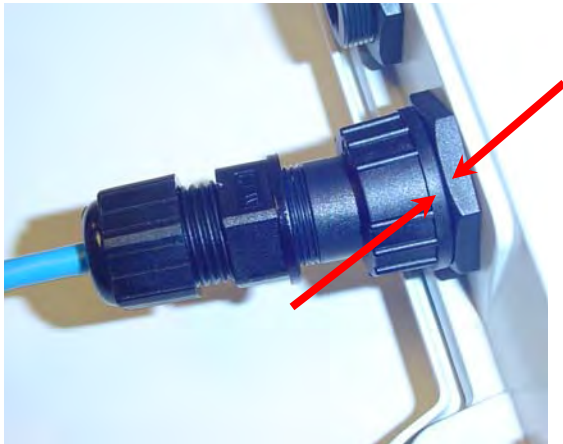
GOOD

NO GAP BETWEEN BOOT AND CONNECTOR ON MESH NODE. CONNECTION IS WATERTIGHT.

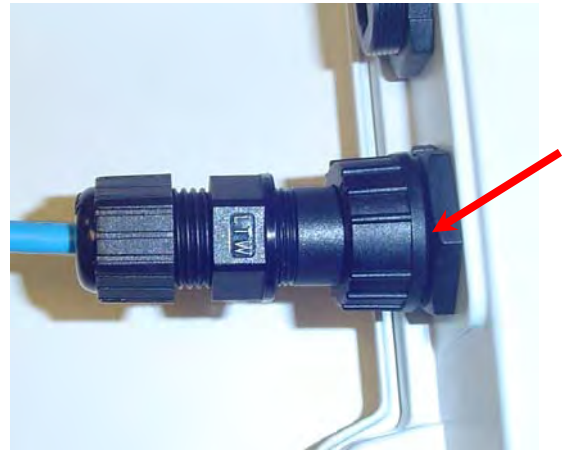
BAD

CONNECTOR IS CROSS-THREADED AND ATTACHED AT A SLANT. WATERTIGHT CONNECTION IS NOT ESTABLISHED.

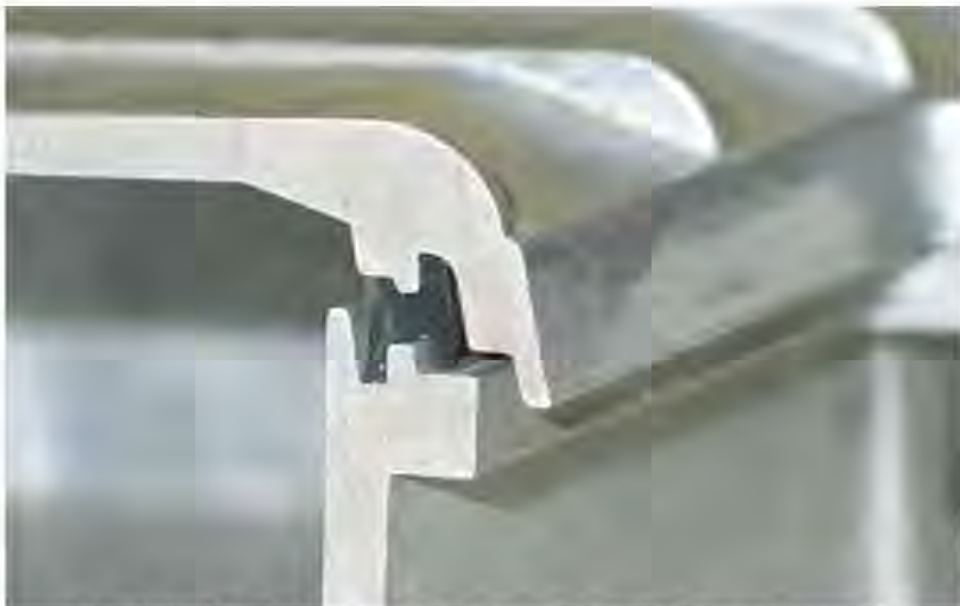
Fig 1.1 WRAP box section and gasket cross-section

c) Place the silicone rubber gasket into the base gasket channels. The gasket forms a perfect seal only if installed like in Fig 1.1. Please note that if gasket is installed upside down, the seal will not be perfect!!!!
